Tracer Wire for HDD Applications

Extensive research and testing has culminated in the release of a new report that provides valuable information on tracer-wire products for use in horizontal directional drilling (HDD) operations.

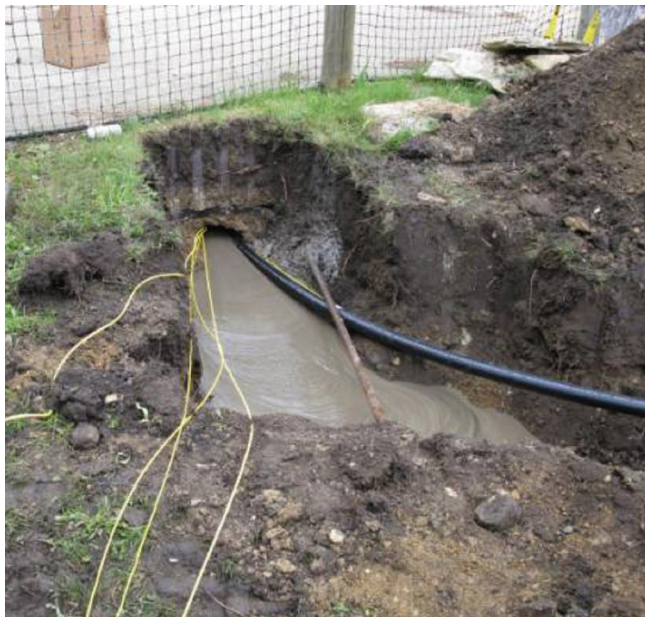
Tracer wires being pulled through the borehole along with the pipe.

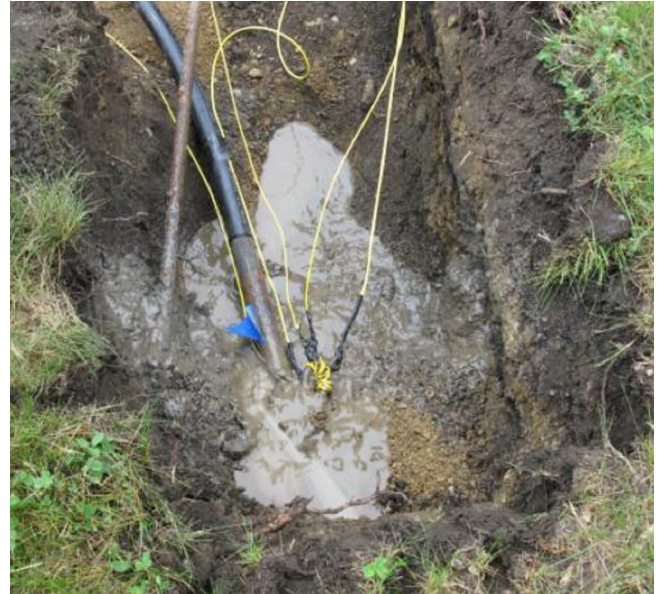
Five tracer wires were used during an HDD pipe installation field test.

A field HDD installation was performed in 2011. Four wires were installed through the HDD installation process. Except for one wire that was left in the field, the tracer wires were pulled out and evaluated.

A second field test was conducted on April 30, 2012, in Batavia, IL. This approximately 340-foot HDD water-pipe installation project was in a very rocky area. Four wires were pulled through and brought back for inspection.
