# **Tracer Wire for HDD Applications**

Report Issued: November 1, 2012

Gas Technology Institute 1700 S. Mount Prospect Rd. Des Plaines, Illinois 60018 www.gastechnology.org

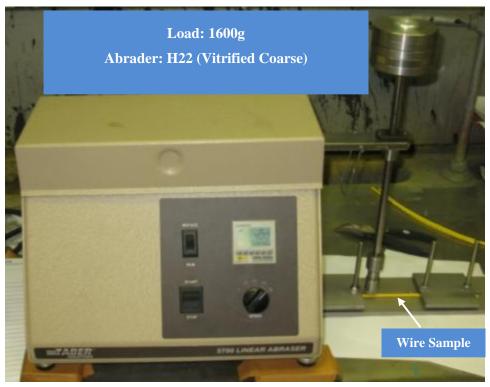
Figure 3. Taber Abrasion Test Setup

- Test Samples
  - Three replicates were used for each product.
  - Tested wire products include:
    - 1. Company E solid copper wire (45 mil LDPE)
    - 2. Company C solid copper wire (45 mil LDPE)
    - 3. Company F (48 mil HDPE and insulation fibers)
    - 4. Company F HDD CCS (45 mil HDPE)
    - 5. Company A HDD CCS (45 mil HDPE)
    - 6. Company D Extra High Strength CCS (45 mil HDPE)
- Test Setup:
  - The wire insulation jacket was tested with Linear Taber Abraser under a 1600 gram load using the H22 Abrader, see Figure 3.
  - The thickness of the insulation jacket before and after 1000 strokes was measured.
- Test Results:
  - Linear Taber abrasion test results are plotted in Figure 4.
  - Company E and Company A HDPE insulation jackets exhibit higher abrasion resistance than other HDPE and LDPE insulation jackets.

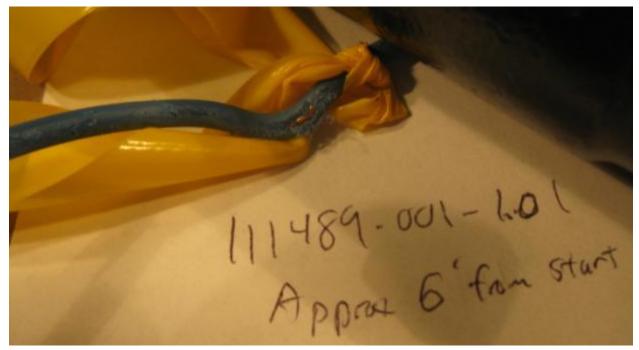
Figure 13. Break of Insulation Jacket (#1) on Field Tested Company A-12 AWG Solid Copper Wire

- Company F wire: One break in the outer jacket coating was visible, see Figure 12. No holiday was detectable in this wire during the high voltage inspection. Although a breach in the outer jacket was detected the conducting wire still contained duel insulation to protect it; insulation on the copper plus the polyester fibers.
- Company A 12 AWG Solid Copper: Total of four holidays were detected, see Figure 13 through Figure 16.
- Company D 12 AWG Copper Clad Steel: Total of three holidays were detected, see Figure 17 through Figure 19.

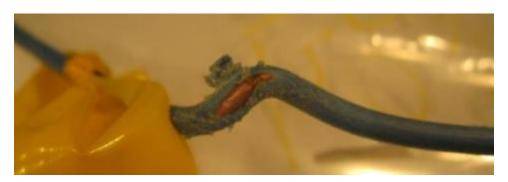
Figure 19. Break of Insulation Jacket (#3) on Field Tested Company D-12 AWG Copper Clad Steel Wire

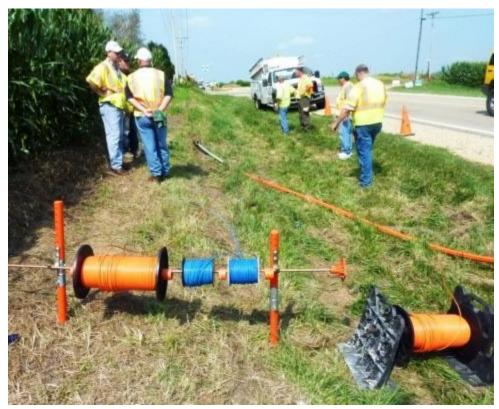
Figure 43. Four tracer wires used during HDD pipe installation

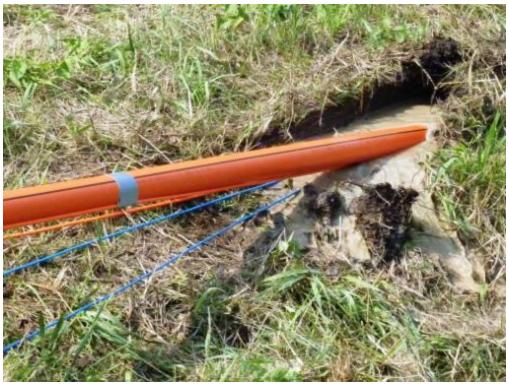
Figure 44. Tracer Wires being Pulled in with Pipe

Note: Permanent wire was taped to pipe.

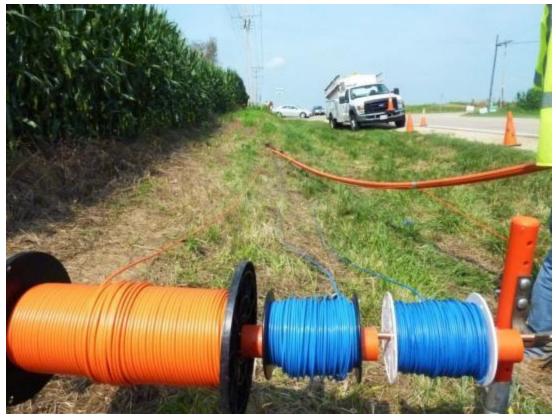
Figure 45. Tracer Wires during Pull In

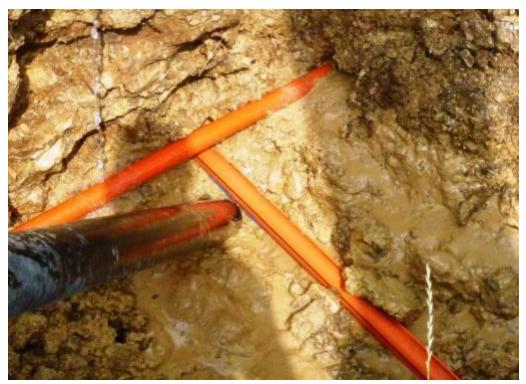
Figure 46. Pipe and Wires Crossing Another Existing Conduit

Note: limestone rock

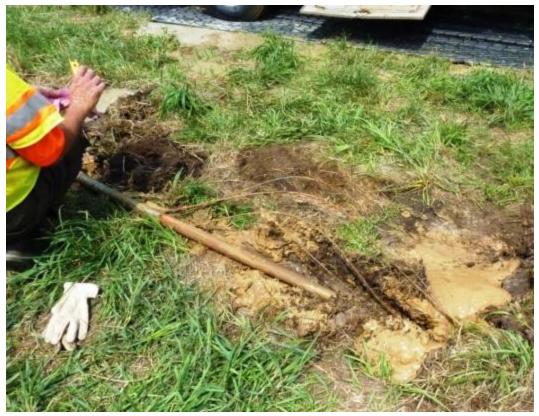
Figure 47. Tracer Wires and Pipe at Exit Point (530' away from Entry Point)

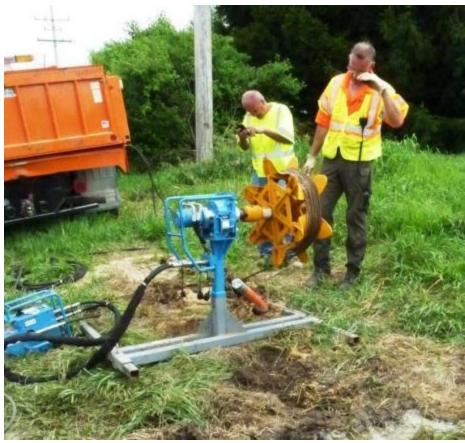
Figure 48. Three Tracer Wires being Pulled out of the Ground

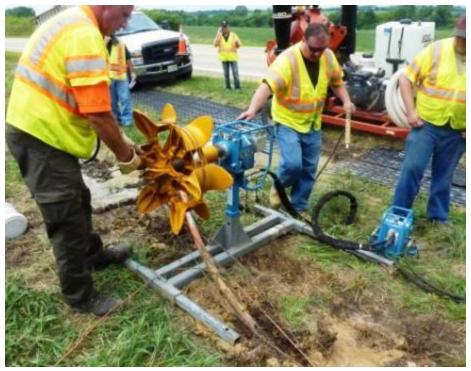
Figure 49. Three Tracer Wires being Pulled out of the Ground

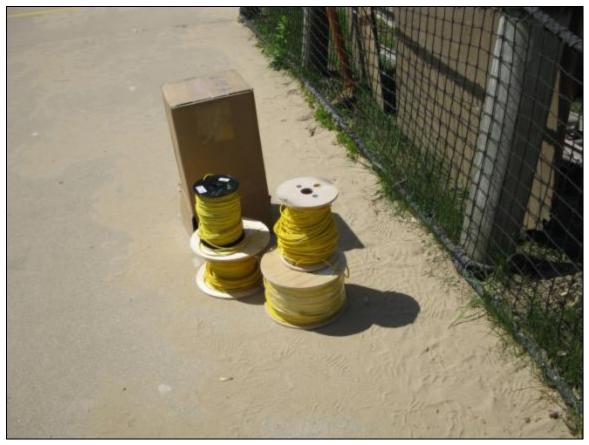
Figure 51.Tracer Wires before the Installation

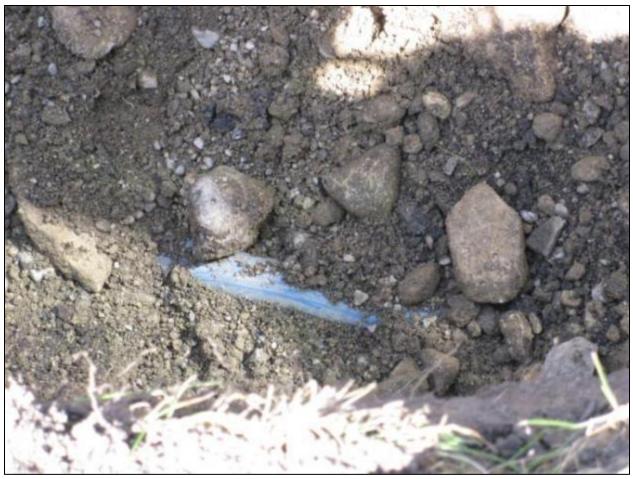
Figure 52. Example of the Rocky Soil Areas

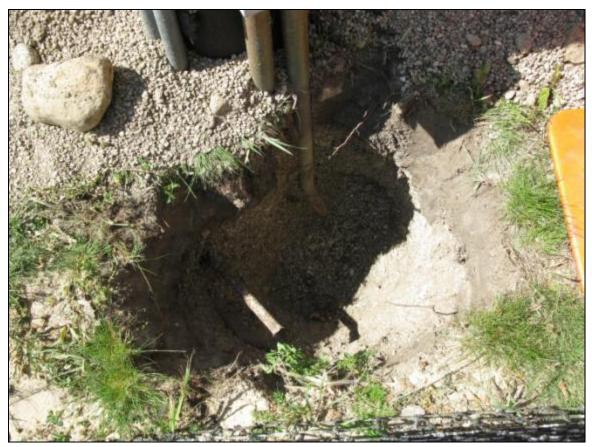
Figure 53. Example of the Pea Gravel Soil

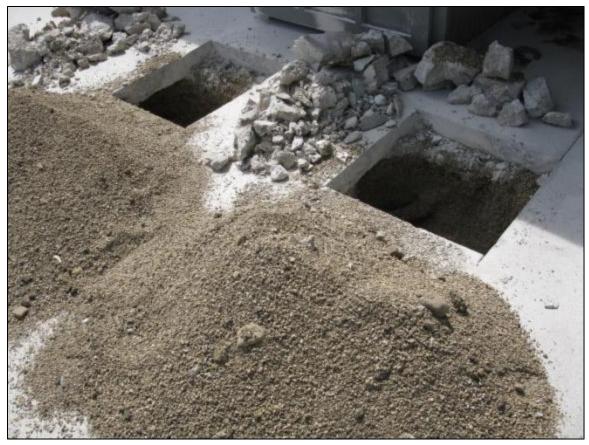
Figure 54. Example of the Pea Gravel with Concrete

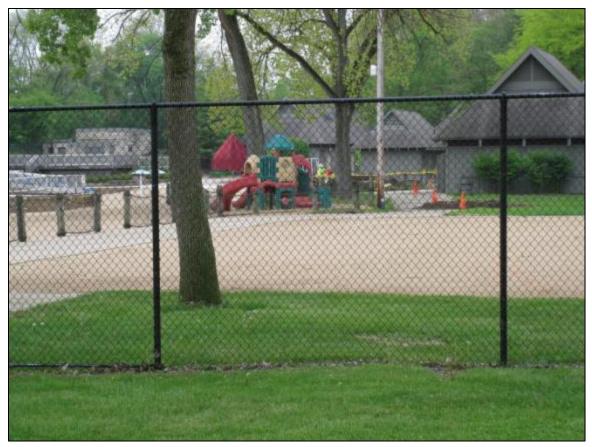
Figure 55. The Sand Area of the Pipe Installation

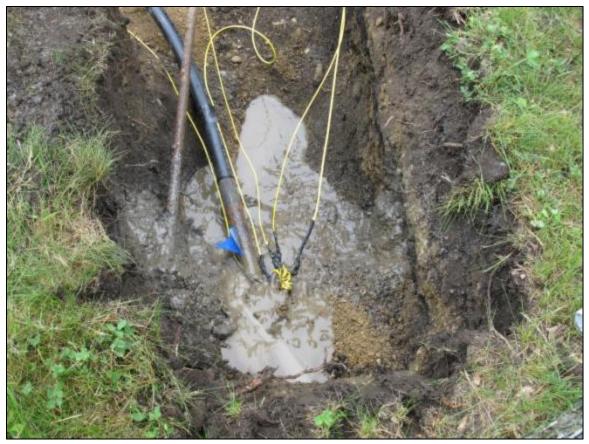
Figure 56. Five Tracer Wires Used during HDD Pipe Installation

Note permanent wire taped to the pipe.

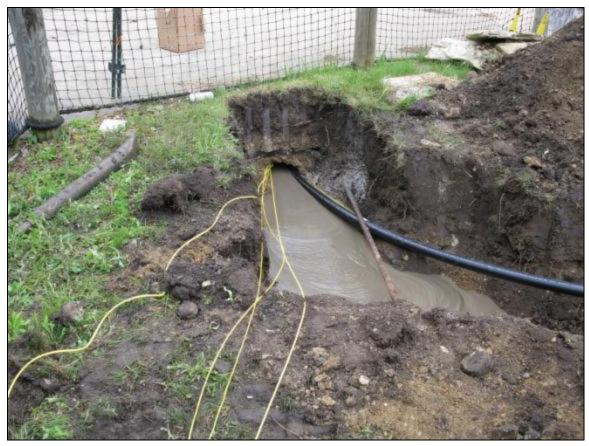
Figure 57. Tracer Wires being Pulled through the Borehole along with the Pipe

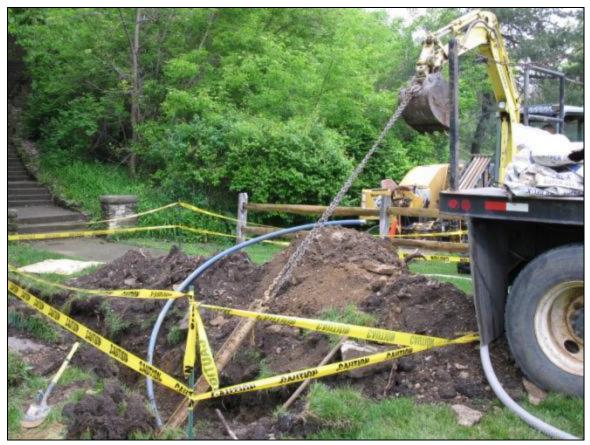
Figure 58. Pipe and Wires being Pulled out by Backhoe
