GTI-OTD FINAL REPORT ADDENDUM

Public Version OTD 5.16.a

Solvent Cleaning and PE Joining Procedures – Final Report Addendum

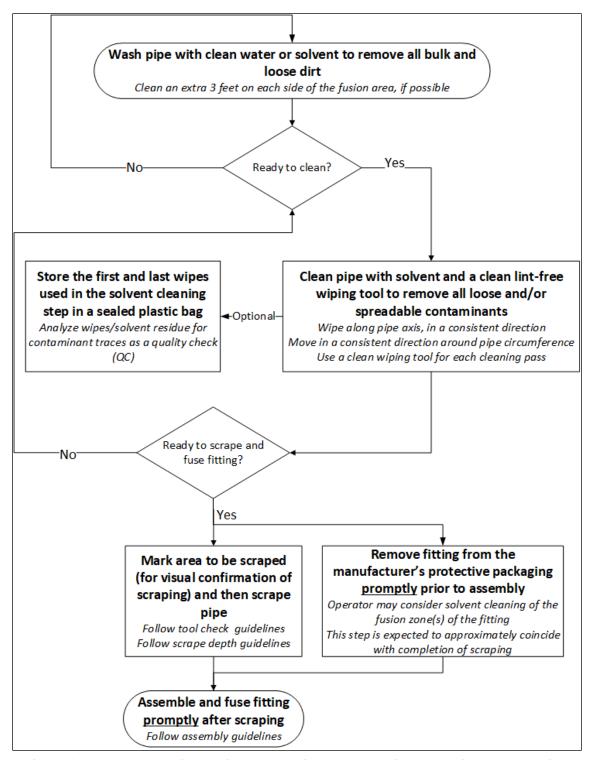
Figure 1 shows a top-level workflow of a generic PE pipe preparation procedure² that incorporates the three critical steps above and other best-practices discussed in the final report. Figure 2 and Figure 3 show the cleaning and scraping areas schematics³ associated with the recommended best-practices procedure.

Figure 1. Top-level generic PE pipe preparation procedure incorporating best-practices

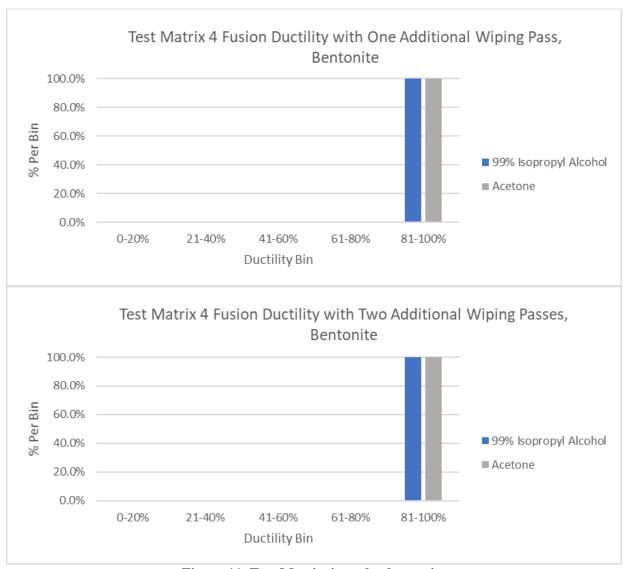
The results of Test Matrix 4 show that repeated solvent wiping passes improved bentonite removal with both 99% isopropyl alcohol and acetone (**Figure 11**).

Figure 11. Test Matrix 4 results, bentonite

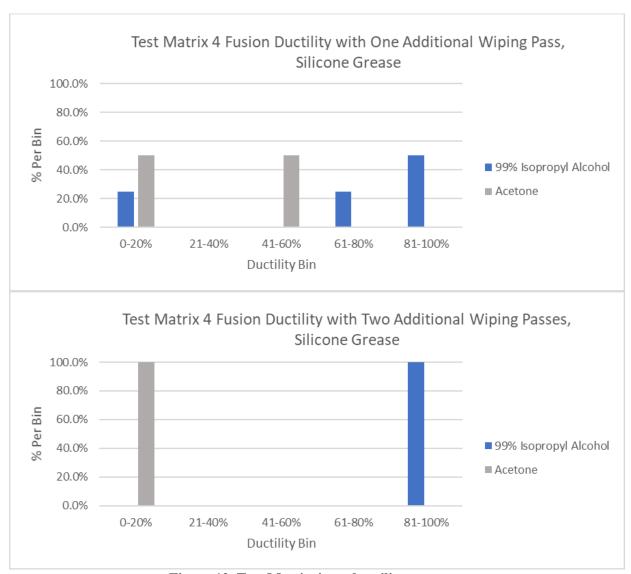
Additional wiping passes also improved silicone grease removal with 99% isopropyl alcohol, but did not appear to improve removal with acetone (**Figure 12**). It should be noted that only four runs with acetone were performed under this matrix and therefore these results should not be treated as definitive.

Figure 12. Test Matrix 4 results, silicone grease

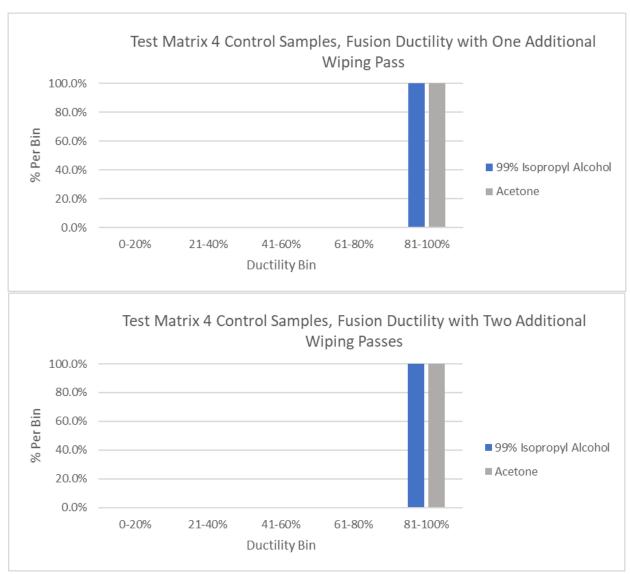
Figure 13 shows the ductility results of the control samples, which were not contaminated. All fusions fell in the 81-100% ductility bin, as expected.

Figure 13. Test Matrix 4 control sample (no contamination) results

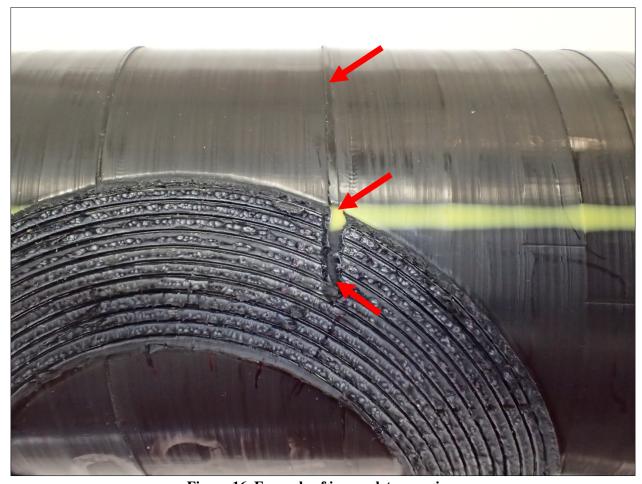
- Removal of loose contaminants is crucial for preventing the transfer of contaminants as scraping is performed, and,
- Scraping is the critical step for removal of any remaining, non-loose, surface contaminants.

Additionally, this example illustrates the importance of operator training on the tools they use and procedural checks of workmanship in the field.

Figure 16. Example of incomplete scraping

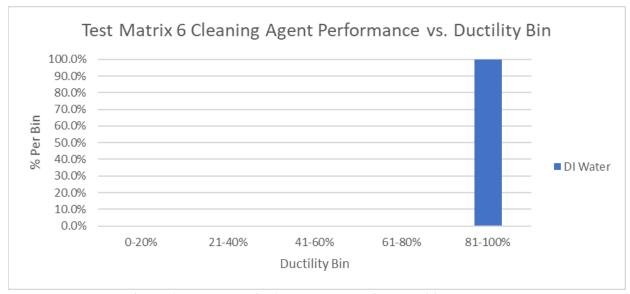
All the fusions from Test Matrix 6 fell within the top ductility band (**Figure 17**), indicating that cleaning with a solvent (or choice of solvent) is not critical. This finding lends support to the understanding that what is critical is that any loose contaminants are thoroughly removed prior to scraping, which is achievable with water⁴. The scraping step is the critical step where non-loose surface contaminants are removed.

Figure 17. Test Matrix 6 results, bentonite and silicone grease

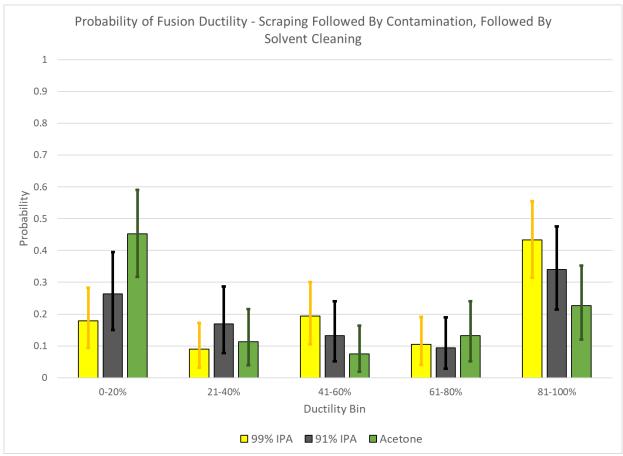
Figure 23 shows a comparison between fusions prepared with different solvents, where scraping was followed by contamination, followed by solvent cleaning. The chart shows what is the probability of a fusion (performed under these conditions) to fall within each ductility bin. The error bars represent the upper and lower credibility bounds of the respective probabilities.

As can be seen in **Figure 23**, fusions that followed solvent cleaning with 99% isopropyl alcohol were more likely to fall within the top ductility bin than 91% isopropyl alcohol. Solvent cleaning with acetone was less likely to produce a fusion in the top ductility bin than both 99% and 91% isopropyl alcohol. Overall, however, when contamination and solvent cleaning follow scraping, all solvents showed the same probability trends with less than a 50% chance of a successful fusion. These probabilities were obtained from 62 99% isopropyl alcohol runs, 48 91% isopropyl alcohol runs, and 48 acetone runs (Test Matrix 1, 3, and 4).

Figure 23. Solvent performance comparison, probability of fusion ductility – scraping followed by contamination, followed by solvent cleaning

Figure 24 shows a comparison between fusions prepared with different solvents (as in **Figure 23**), but for fusions where scraping followed contamination and solvent cleaning. The results for fusions performed on pipes that were prepared with different solvents are the same in this case; showing a high probability of a successful fusion, due to scraping being the final preparation step before fusion. These probabilities were obtained from 20 99% isopropyl alcohol runs, eight 91% isopropyl alcohol runs, and 16 acetone runs (Test Matrix 2, 5, and 6).

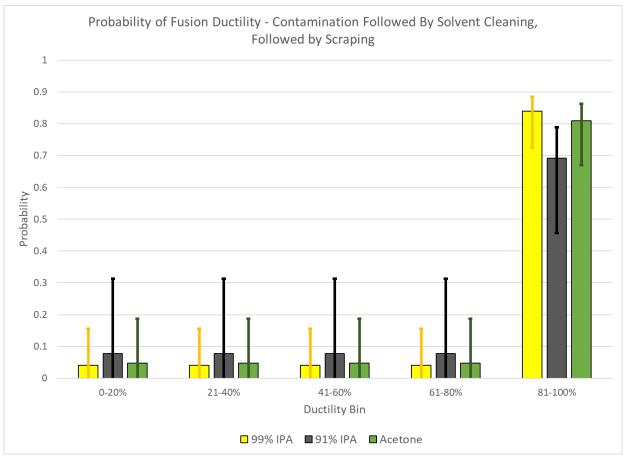
Figure 24. Solvent performance comparison, probability of fusion ductility – contamination followed by solvent cleaning, followed by scraping

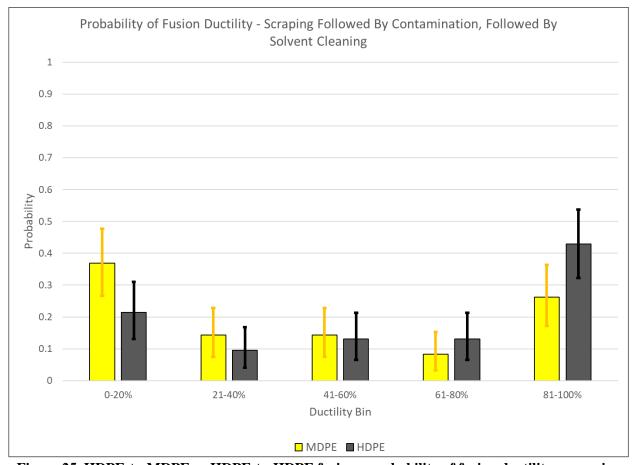
Figure 25 shows a comparison between the fusions performed on MDPE pipe and HDPE pipe, where scraping was followed by contamination, followed by solvent cleaning. The chart shows what is the probability of a fusion (performed under these conditions) to fall within each ductility bin. The error bars represent the upper and lower credibility bounds of the respective probabilities.

As can be seen in **Figure 25**, fusions performed on HDPE pipe exhibited a higher probability that the ductility will fall in the desired 81-100% bin, as compared to fusions performed on MDPE pipe. It should be noted here that all electrofusion saddle fittings were made from HDPE and, therefore, this result is likely reflecting a difference between HDPE-to-HDPE and HDPE-to-MDPE fusions when contamination is present.

Overall, however, when contamination and solvent cleaning follow scraping, the fusion to HDPE and MDPE pipes showed the same probability trends with less than a 50% chance of a successful fusion. These probabilities were obtained from 79 fusions per pipe material (Test Matrix 1, 3, and 4).

Figure 25. HDPE-to-MDPE vs HDPE-to-HDPE fusions, probability of fusion ductility – scraping followed by contamination, followed by solvent cleaning

Figure 26 shows a comparison between fusions performed on MDPE pipe and HDPE pipe (as in **Figure 25**), but for fusions where scraping followed contamination and solvent cleaning. The results for fusions performed on HDPE and MDPE pipes are the same in this case; showing a high probability of a successful fusion. These probabilities were obtained from 24 fusions per pipe material (Test Matrix 2, 5, and 6).

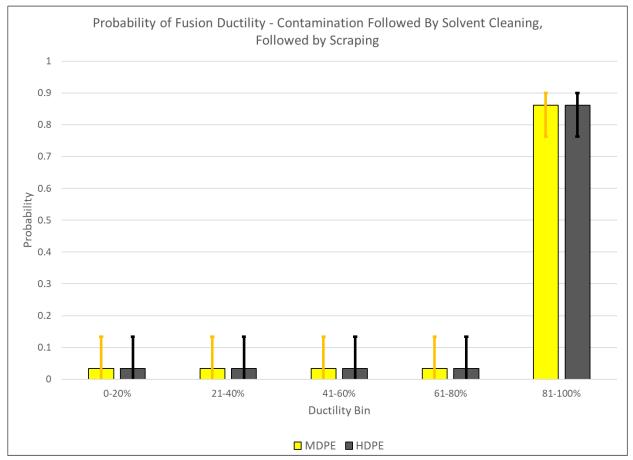
Figure 26. HDPE-to-MDPE vs HDPE-to-HDPE fusions, probability of fusion ductility – contamination followed by solvent cleaning, followed by scraping

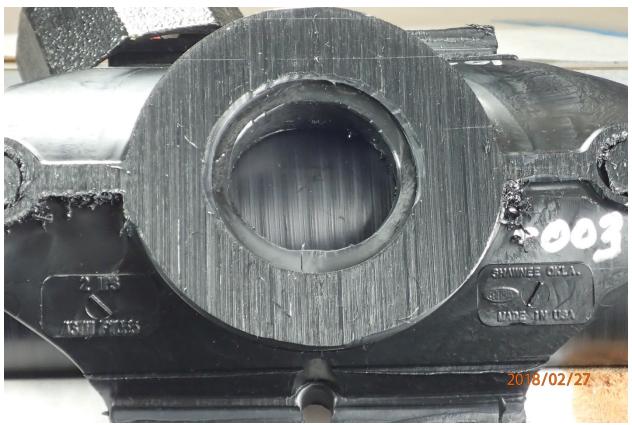
Figure 73. Test Matrix 4, Run Index 47, saddle did not fully separate from the pipe during the decohesion test

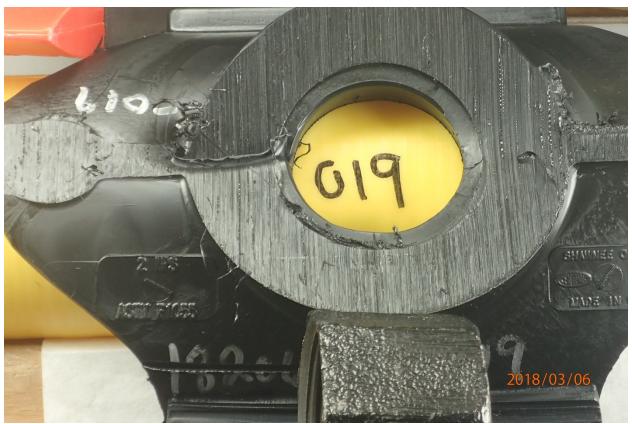
Figure 105. Test Matrix 4, Run Index 79, saddle did not fully separate from the pipe during the decohesion test

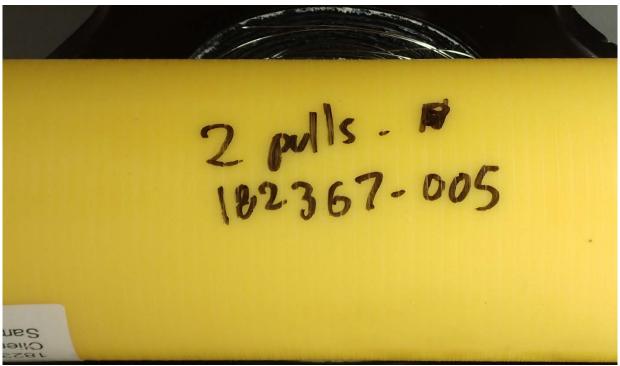
Figure 151. Test Matrix 7, Run Index 125 (saddle did not fully separate from pipe)

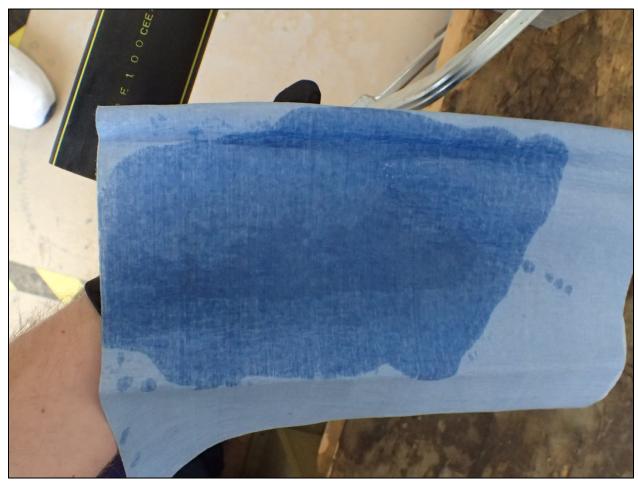
Figure 159. Wetting of a lint-free wipe with a solvent

The following figures are provided for general reference on the wiping technique employed on tests performed under this project (final report and addendum tests). Although the examples here show only one cleaning tool (lint-free wipe) and contaminant (bentonite powder), the technique was applied identically for all cleaning tools, solvents, and contaminants.

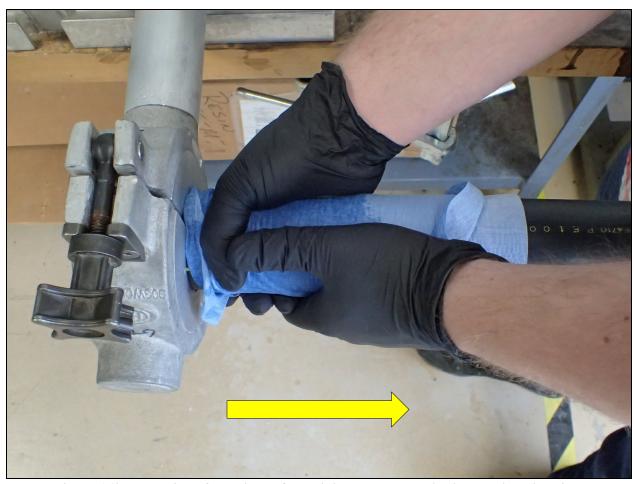
Figure 160. Wrapping of the pipe before wiping pass, arrow indicates wipe direction

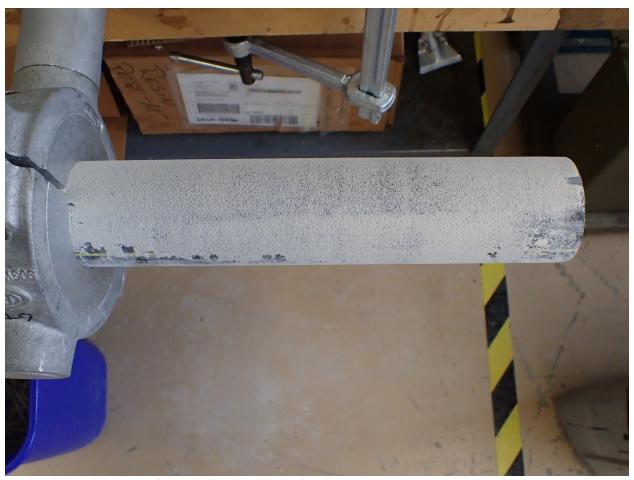
Figure 161. Pipe contaminated with bentonite powder

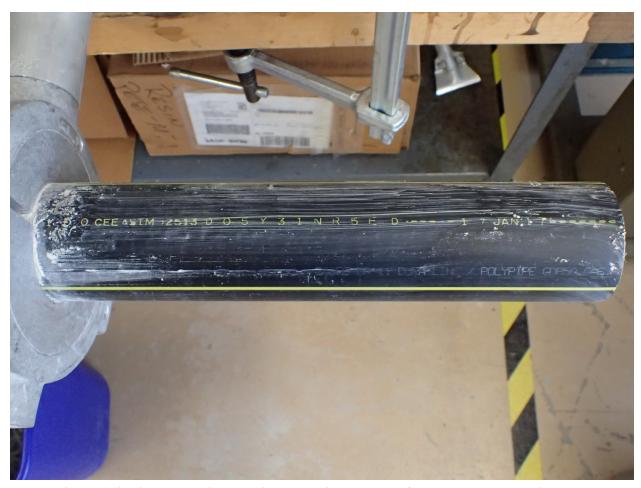
Figure 162. Pipe contaminated with bentonite powder, after one solvent cleaning pass

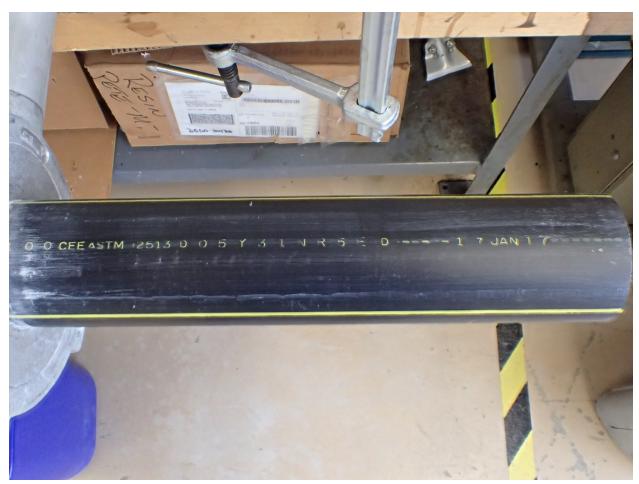
Figure 163. Pipe contaminated with bentonite powder, after two solvent cleaning passes

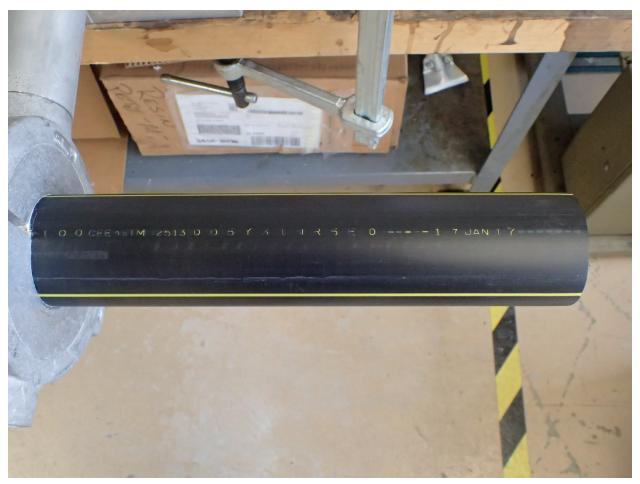
Figure 164. Pipe contaminated with bentonite powder, after three solvent cleaning passes, as necessary to make the surface visually appear to be clean; loose contamination has been removed

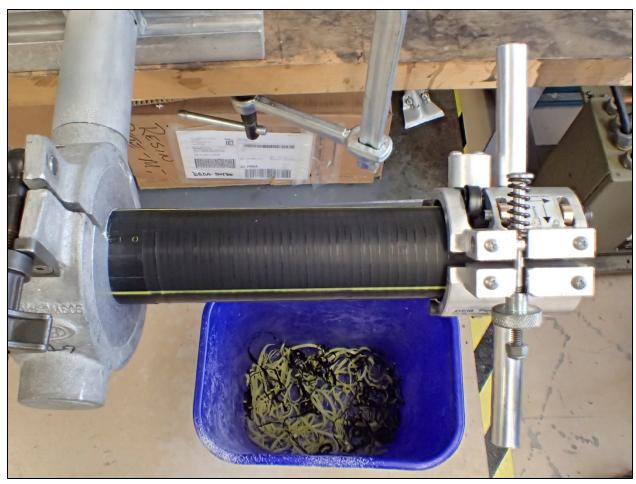
Figure 165. Pipe contaminated with bentonite powder, end of scraping pass

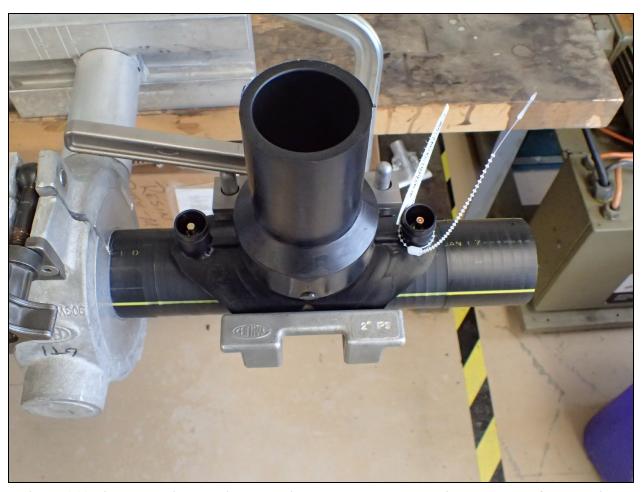
Figure 166. Pipe contaminated with bentonite powder, saddle clamping promptly after scraping
